# Manhole Inspection Summary

Manhole # S17K1\_010MH

Insp Date: **4/30/08 12:20 PM**

**Location** Address: **2699 gable av**

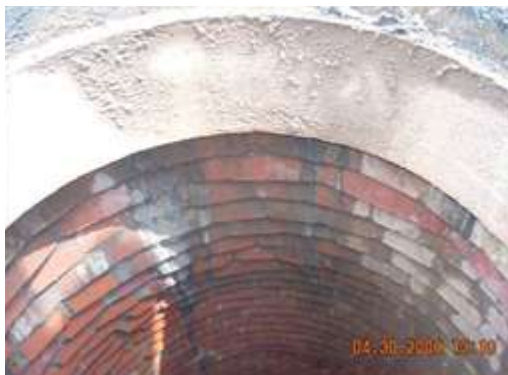
Defect 4

**Frame** Offset: **0** (in.) Condition: ☐ Sound ☐ Cracked ☒ **Leaks**

Frame leaks-inflow evidence from sheeting

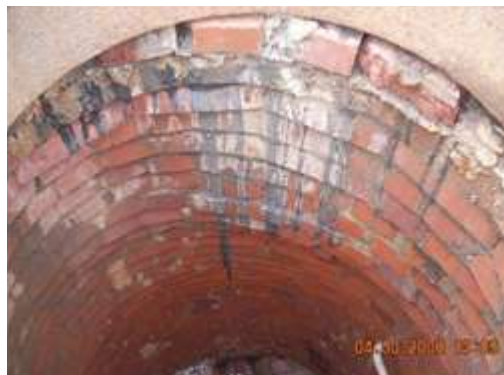
Defect 3

Infiltration: ☐ None ☒ **Joint** ☐ Cracks ☐ Mortar ☐ Roots ☐ Wall

infiltration @ chimney/frame joint

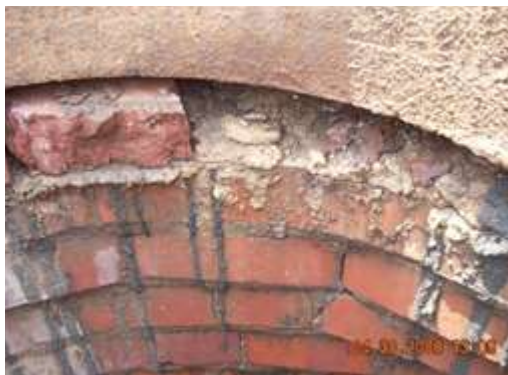
Defect 2

Condition: ☐ Sound ☐ Cracked ☐ Root Intrusion ☐ Loose Brick ☒ **Deteriorated**

deteriorated chimney

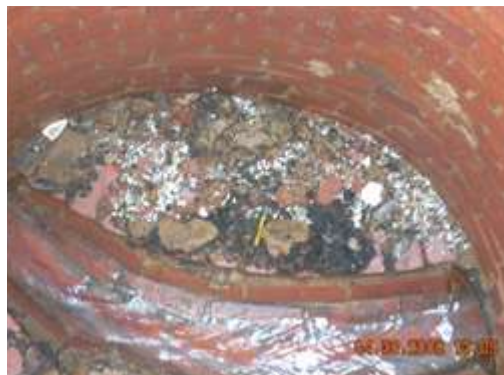
Defect 1

Condition: ☐ Sound ☐ Cracked ☐ Root Intrusion ☐ Deteriorated ☐ Leaks ☒ **Debris**

debris on bench

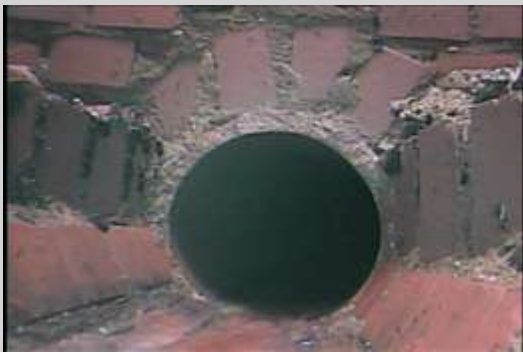
12 O'Clock Outflow

Pipe Height: **8.4** (in.) Rod and Bar (Angled)  
Pipe Material: **Clay** ☐ Pipe Lined  
Invert Depth: **9.20** (ft.) Flow Characteristics: **Slow**  
Deposits: ☒ None ☐ Mud ☐ Sludge ☐ Debris ☐ Grease  
Silt Depth: **0** (in.) Deposits Extent:  
Infiltration: **None** Pipe Seal Cond: **Sound**

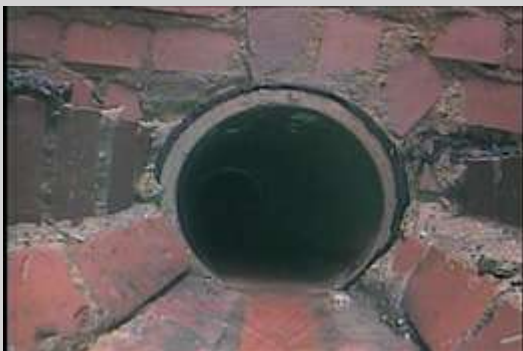
4 O'Clock Inflow

Pipe Height: **8.4** (in.) Rod and Bar (Angled)  
Pipe Material: **Clay** ☐ Pipe Lined  
Invert Depth: **9.02** (ft.) Flow Characteristics: **Slow**  
Deposits: ☒ None ☐ Mud ☐ Sludge ☐ Debris ☐ Grease  
Silt Depth: **0** (in.) Deposits Extent:  
Infiltration: **None** Pipe Seal Cond: **Sound**
